Implant Surface Enhancement – Myth and Reality

Comparative Analysis of Currently Available Implants

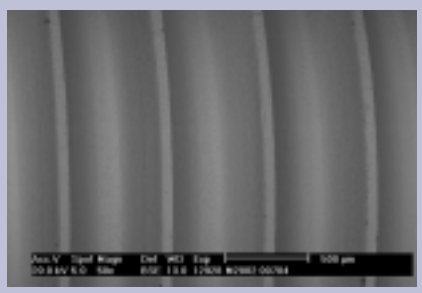
Figure A1 *Embedded particles on threads.*

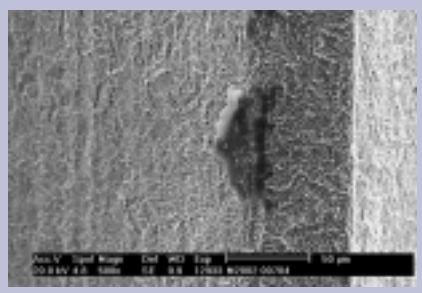
Figure A4 *Embedded particle; magnification 500x.*

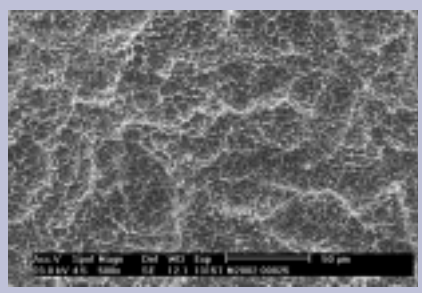
Figure B2 *Topography of grit-blasted and acid-etched surface.*

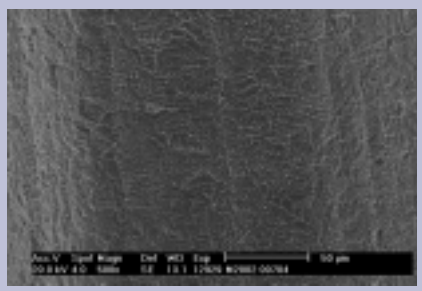
Figure A2 *Topography of solely acid-etched surface.*

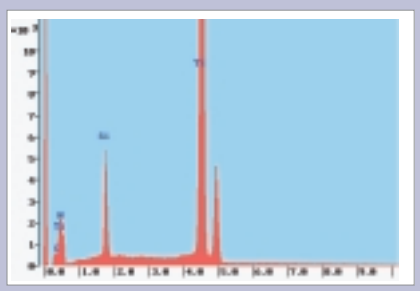
Figure A5 *XRM-analysis of embedded particle. Possible source: sealing cap used for protection while etching.*

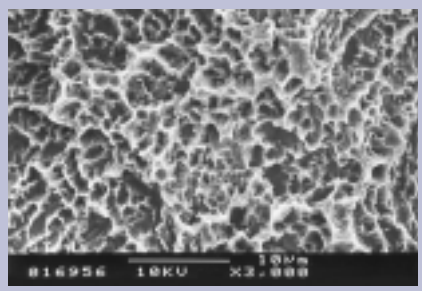
Figure B3 *Homogeneous topography of grit-blasted and acid-etched surface.*

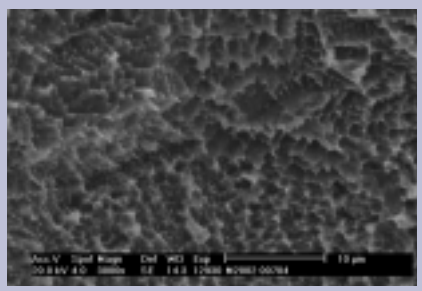
Figure A3 *Slightly inhomogeneous surface structures.*

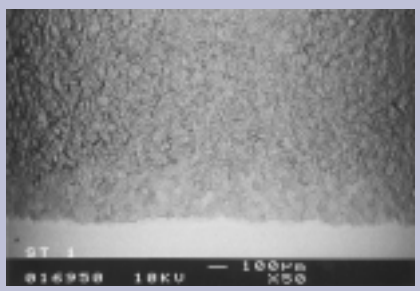
Figure B1 *Surface of grit-blasted and acid etched implant.*

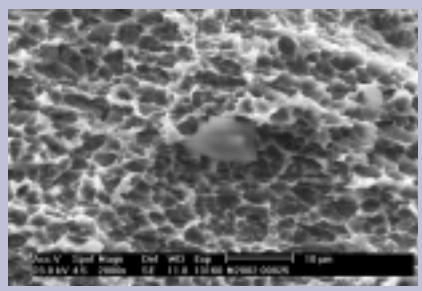
Figure B4 *Grit particle on surface; magnification 2000x.*

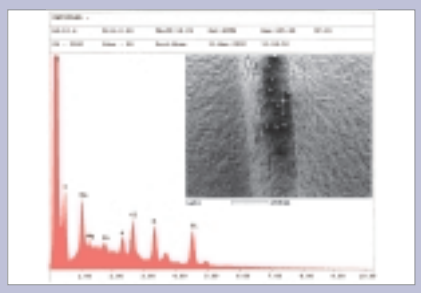
Figure B5 *XRM-analysis of surface; high concentration of phosphorus (claimed as pure TiO2-surface).*

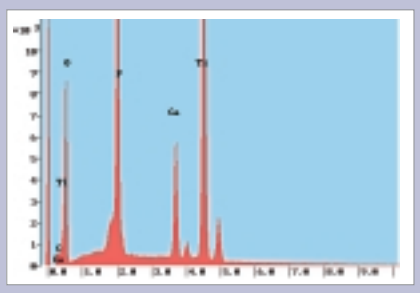
Figure D5 *XRM-analysis showing presence of calcium and phosphorus.*

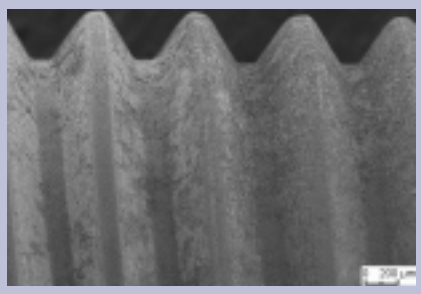
Figure C1 *Inhomogeneous surface morphology, produced by anodic oxidation.*

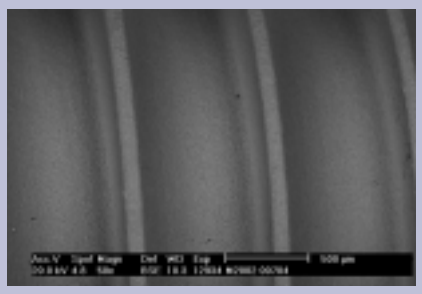
Figure D1 *Inhomogeneous porosities on threads.*

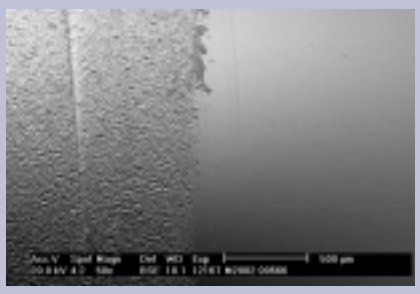
Figure E1 *Embedded particle on transition area.*

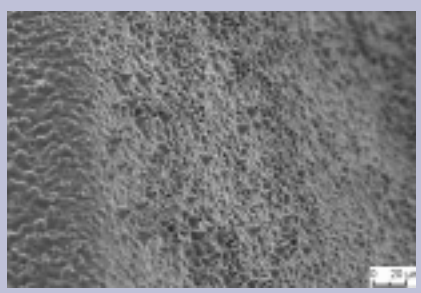
Figure C2 *Topography of surface produced by anodic oxidation; porous structures.*

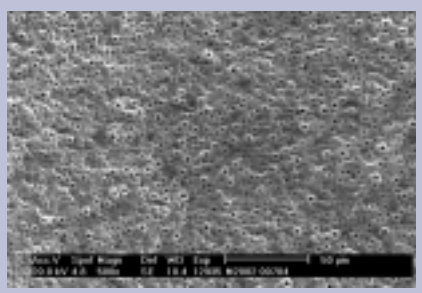
Figure D2 *Topography of surface produced by anodic oxidation; similarity to TiUnite surface.*

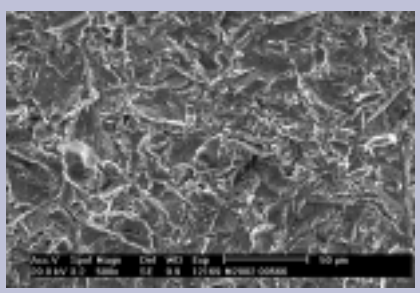
Figure E2 *Structure of solely grit-blasted surface.*

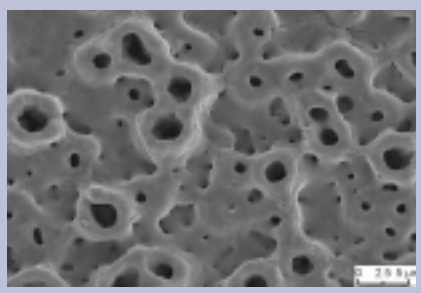
Figure C3 *Cracked surface and highly inhomogeneous distribution of porous structures.*

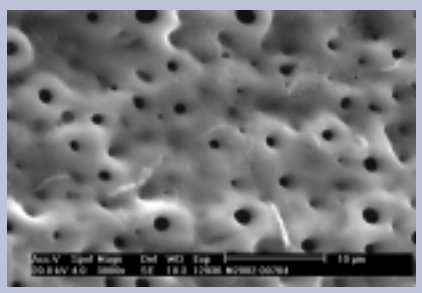
Figure D3 *Cracked surface and inhomogeneous distribution of porosities.*

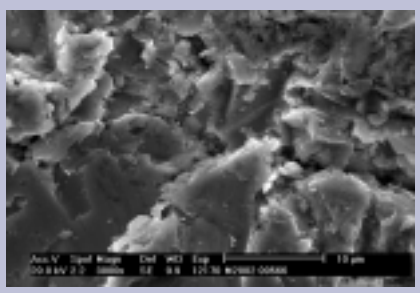
Figure E3 *Structure with presence of grit particles.*

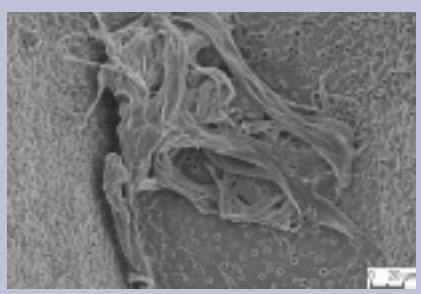
Figure C4 *Foreign fibrous particle on surface; magnification 500x.*

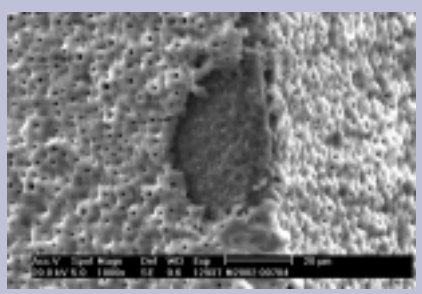
Figure D4 *Surface defect; magnification 1000x.*

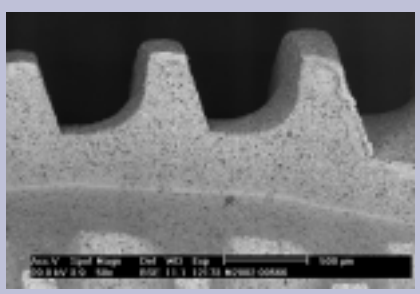
Figure E4 *Surface defect on threads; magnification 50x.*

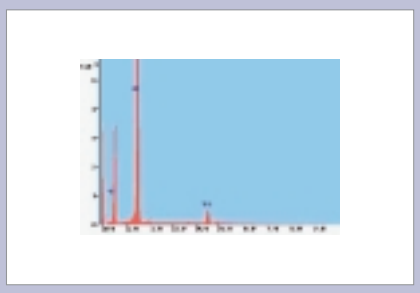
Figure E5 *XRM-analysis of grit particle; identified as aluminium oxide.*

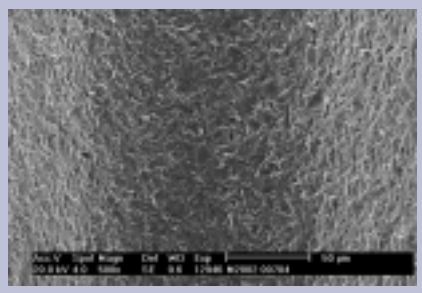
Figure F2 *Structure of titanium-blasted surface.*

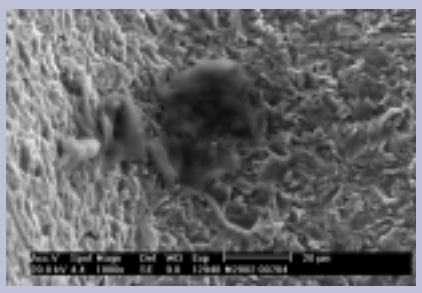
Figure F4 *Embedded particle; magnification 1000x.*

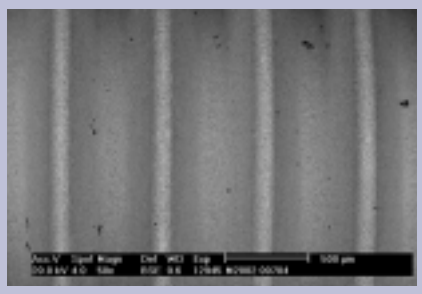
Figure F1 *Embedded particles on surface.*

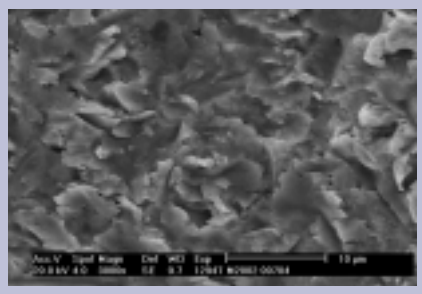
Figure F3 *Slightly inhomogeneous blasted surface.*

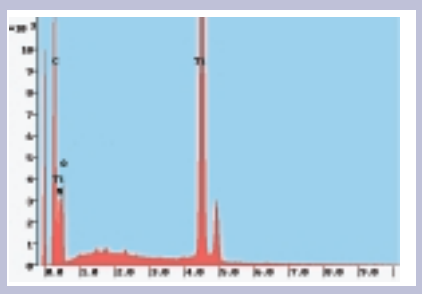
Figure F5 *XRM-analysis of embedded particle. Source: organic material.*
